Title: Computational Modeling of NEXT 2000-hour Wear Test Results

Computational Modeling of NEXT 2000-hour Wear Test Results

NASA Glenn Research Center
Cleveland, Ohio

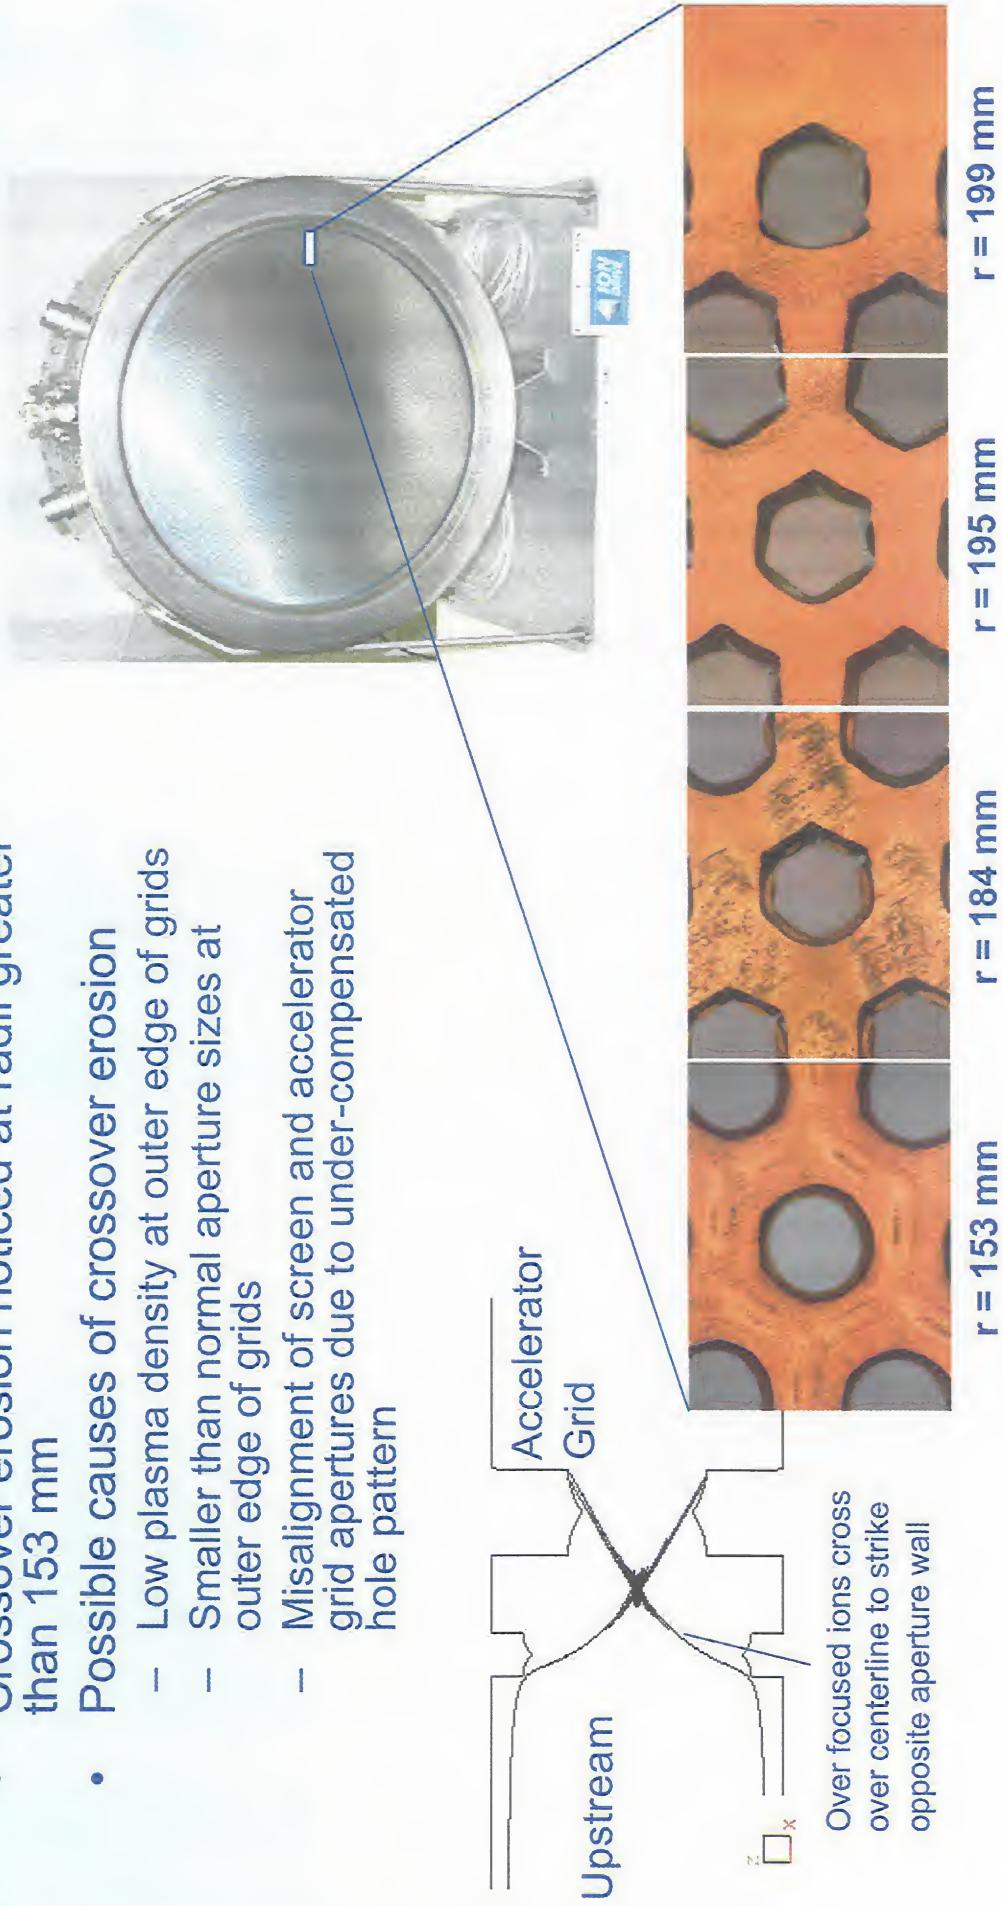
NEXT Crossover Erosion

- Crossover erosion noticed at radii greater than 153 mm
- Possible causes of crossover erosion
 - Low plasma density at outer edge of grids
 - Smaller than normal aperture sizes at outer edge of grids
 - Misalignment of screen and accelerator grid apertures due to under-compensated hole pattern

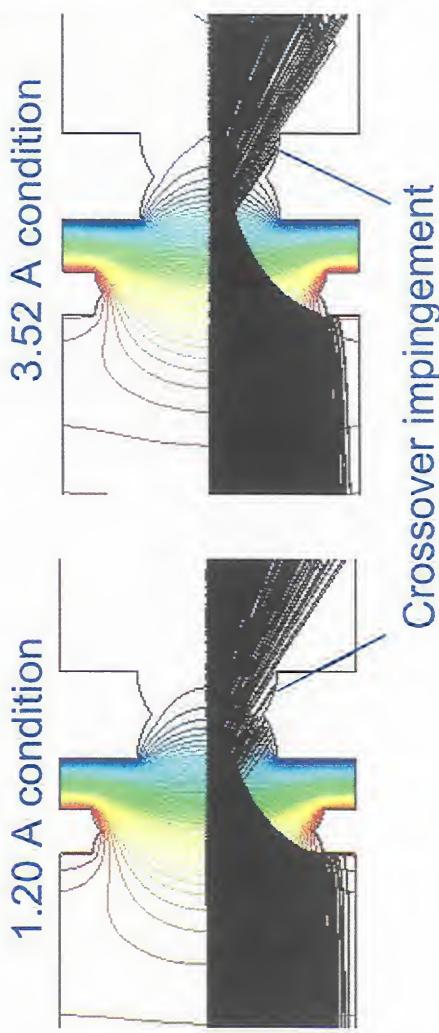
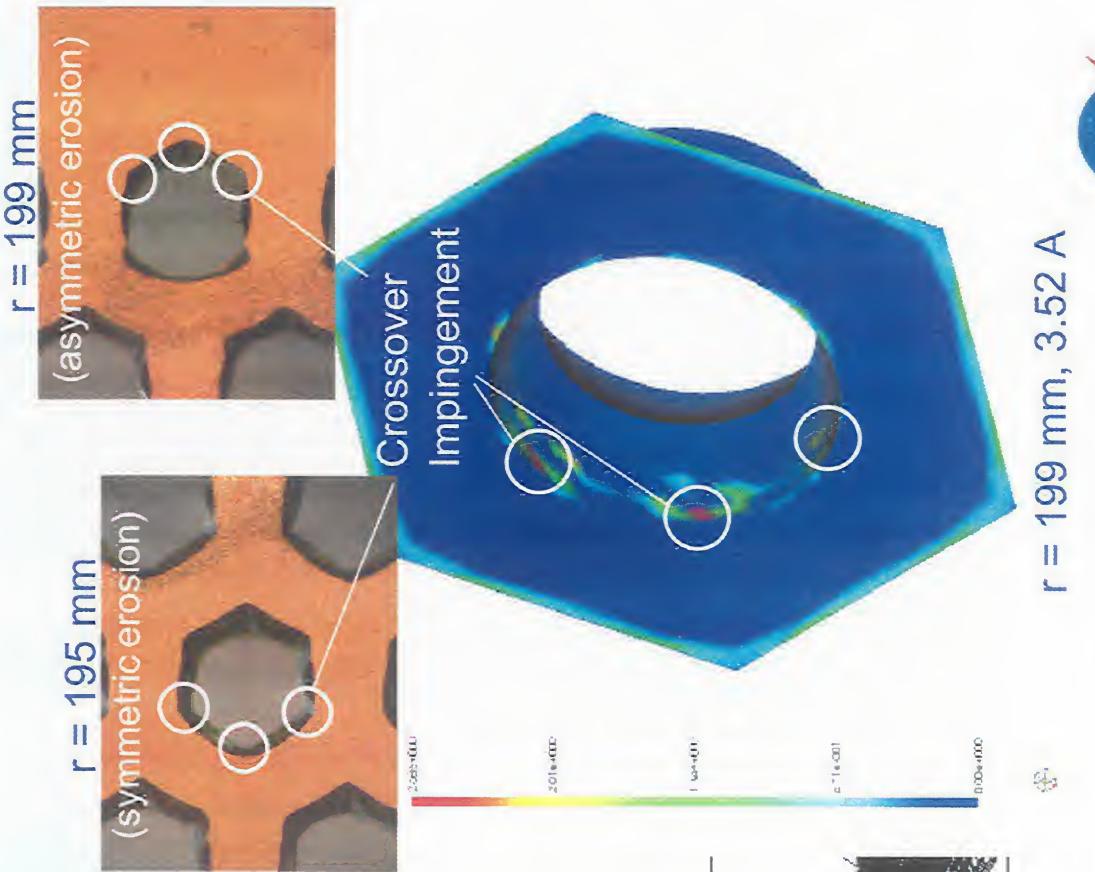
Crossover Erosion at $r = 199$ mm

- Model clearly indicates impingement of crossover ions on accelerator grid aperture barrel
- Current deposition pattern indicates most ion impingement along hex “points”, matching pattern seen in wear test

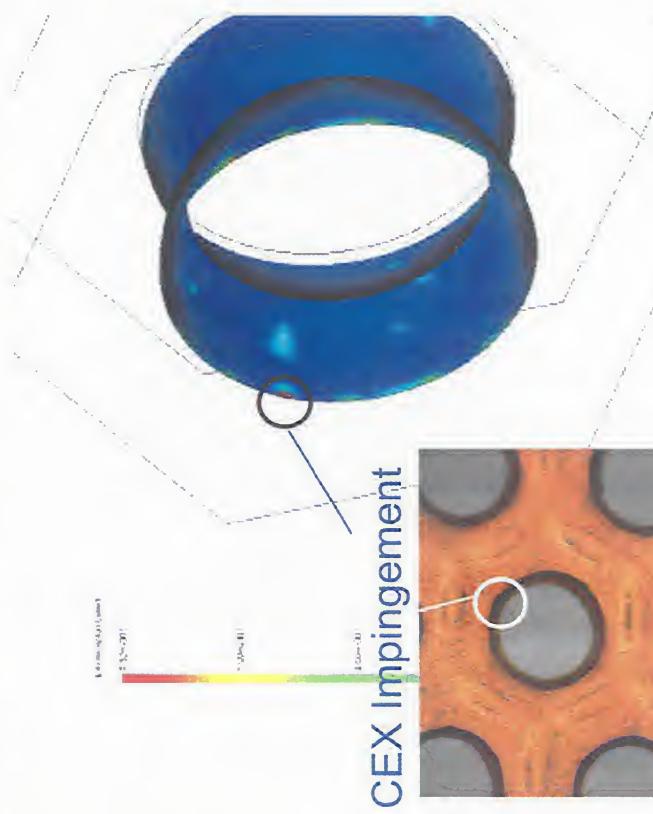
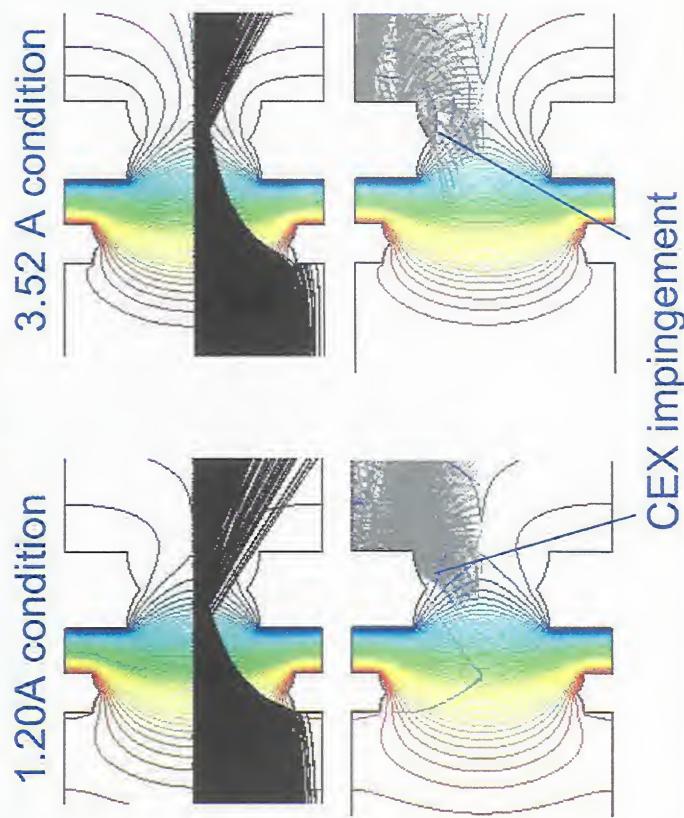
Crossover Erosion at $r = 153$ mm

- Crossover impingement by primary beam ions **not seen in model results**
- Small impingement of medium and high energy intergrid CEX ions **may contribute to slight erosion along webbing direction**
 - Aperture enlargement effect – looks like crossover erosion due to hex shaping of barrel

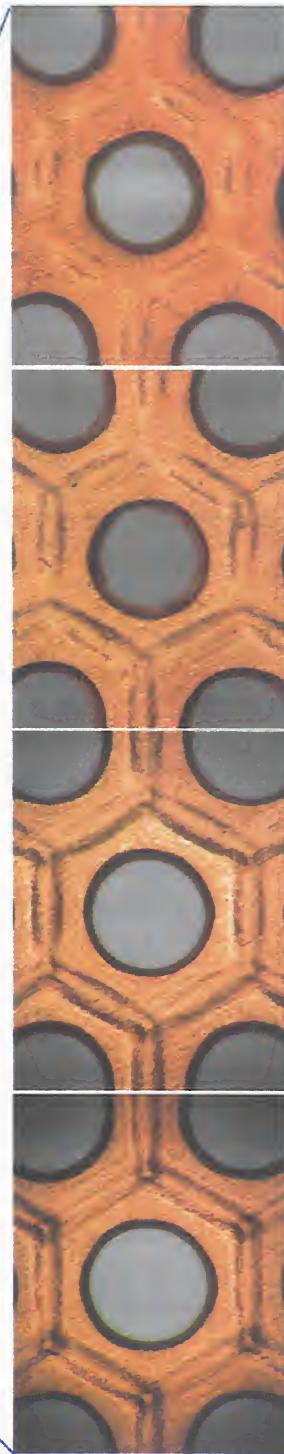
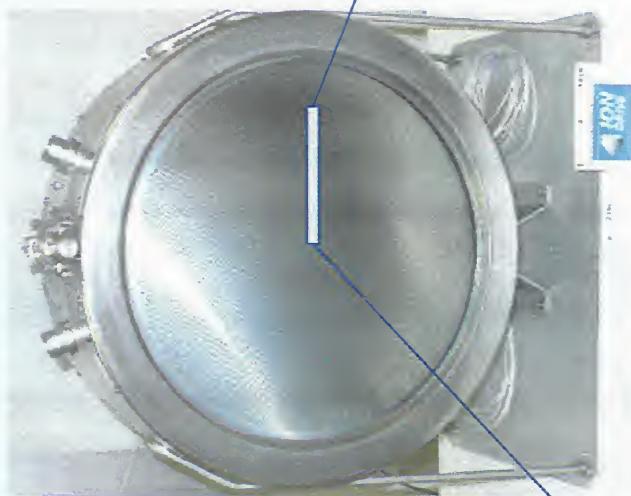
NEXT Pit-and-Groove Erosion

- Pit-and-groove erosion noticed at radii less than 153 mm
- Pit erosion most nearer to thruster centerline
- Groove erosion highest near quarter radius of thruster
- Caused by charge exchange ions formed downstream of the ion optics

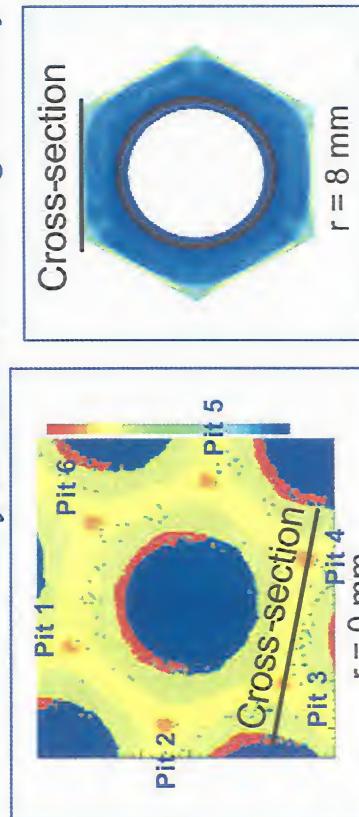
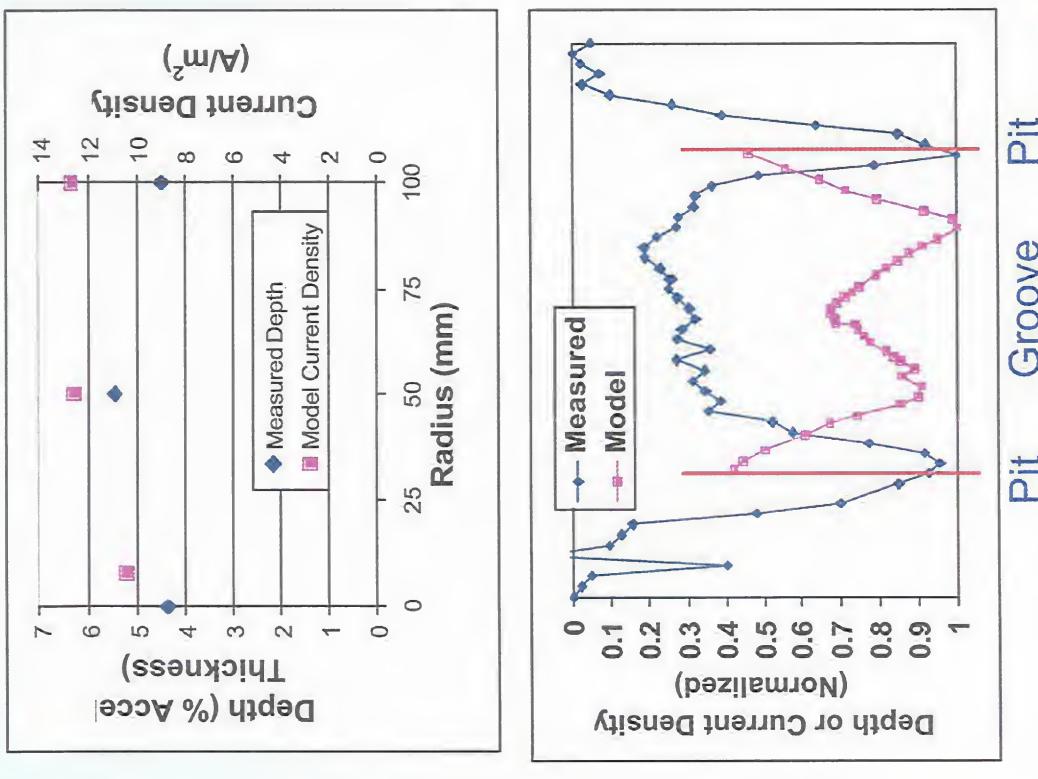
Analysis of Pit-and-Groove Erosion

- Model shows similar trend to measured data regarding groove depth
 - Grooves are deeper away from thruster centerline
- Model does not agree with pit and groove pattern near thruster centerline
 - Model indicates deep groove rather than pit
 - May be due to mesh geometry
